# Manhole Inspection Summary

Manhole # S51AA\_024MH

Insp Date: **3/3/08 1:28 PM**

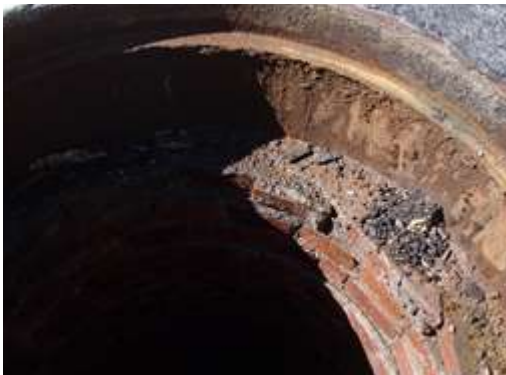
Defect 2

Offset

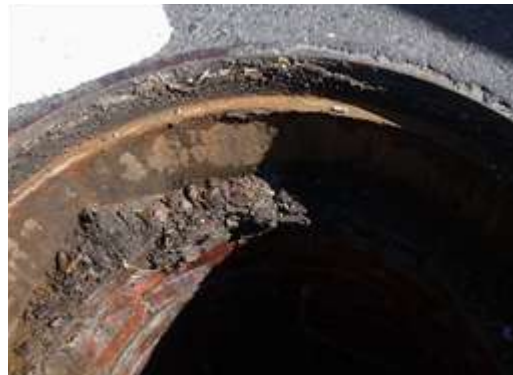
Defect 1

Adjustment Joint

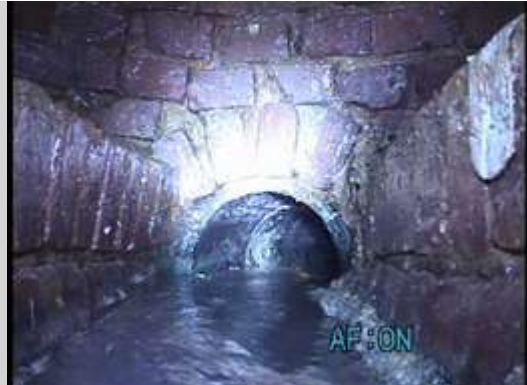
12 O'Clock Outflow

8 in. Circular Gravity Sewer  
Pipe Out @ 12 O'Clock

Pipe Height: **8.4** (in.) Rod and Bar (Angled)  
Pipe Material: **Clay** ☐ Pipe Lined  
Invert Depth: **19.20** (ft.) Flow Characteristics: **Fast**  
Deposits: ☒ None ☐ Mud ☐ Sludge ☐ Debris ☐ Grease  
Silt Depth: (in.) Deposits Extent:  
Infiltration: **None** Pipe Seal Cond: **Sound**

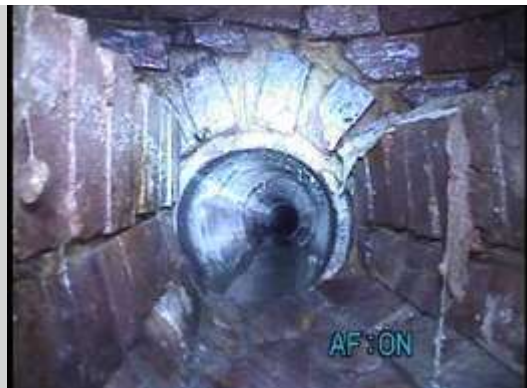
6 O'Clock Inflow

8 in. Circular Gravity Sewer  
Pipe In @ 6 O'Clock

Pipe Height: **8.4** (in.) Rod and Bar (Angled)  
Pipe Material: **Clay** ☐ Pipe Lined  
Invert Depth: **18.80** (ft.) Flow Characteristics: **Fast**  
Deposits: ☒ None ☐ Mud ☐ Sludge ☐ Debris ☐ Grease  
Silt Depth: (in.) Deposits Extent:  
Infiltration: **None** Pipe Seal Cond: **Sound**
